Industry
Canada

December 2008

Report

Safety Code 6 (SC6) Measurement on Triangle Mountain in Colwood, British Columbia

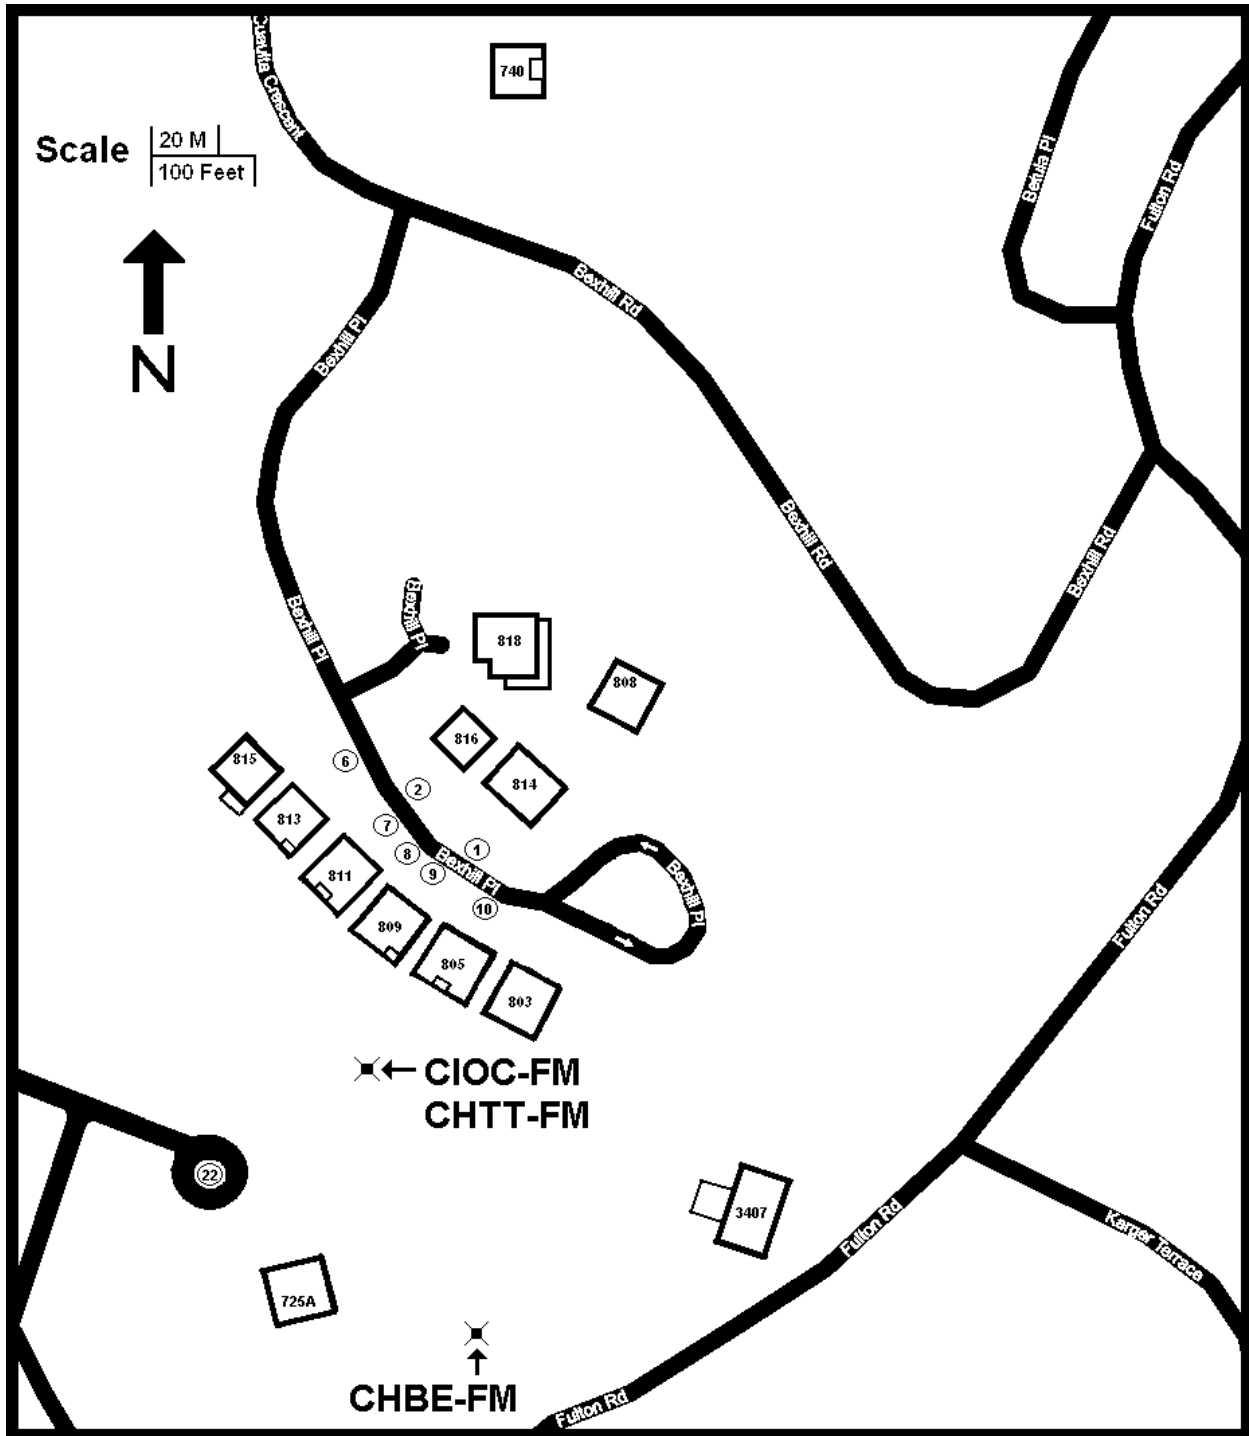
Figure 1 shows the map of the Triangle Mountain antenna site. Measurement locations are shown in circled numbers. Only location numbers in public places are shown in the map.

Figure 1: Map with measurement location numbers in public places, for July and August 2008 on Triangle Mountain in Colwood, B.C.

The public measurement locations are identified by numbers in **Figure 1**. To respect the privacy of individuals, residential measurement locations are not identified in this report.

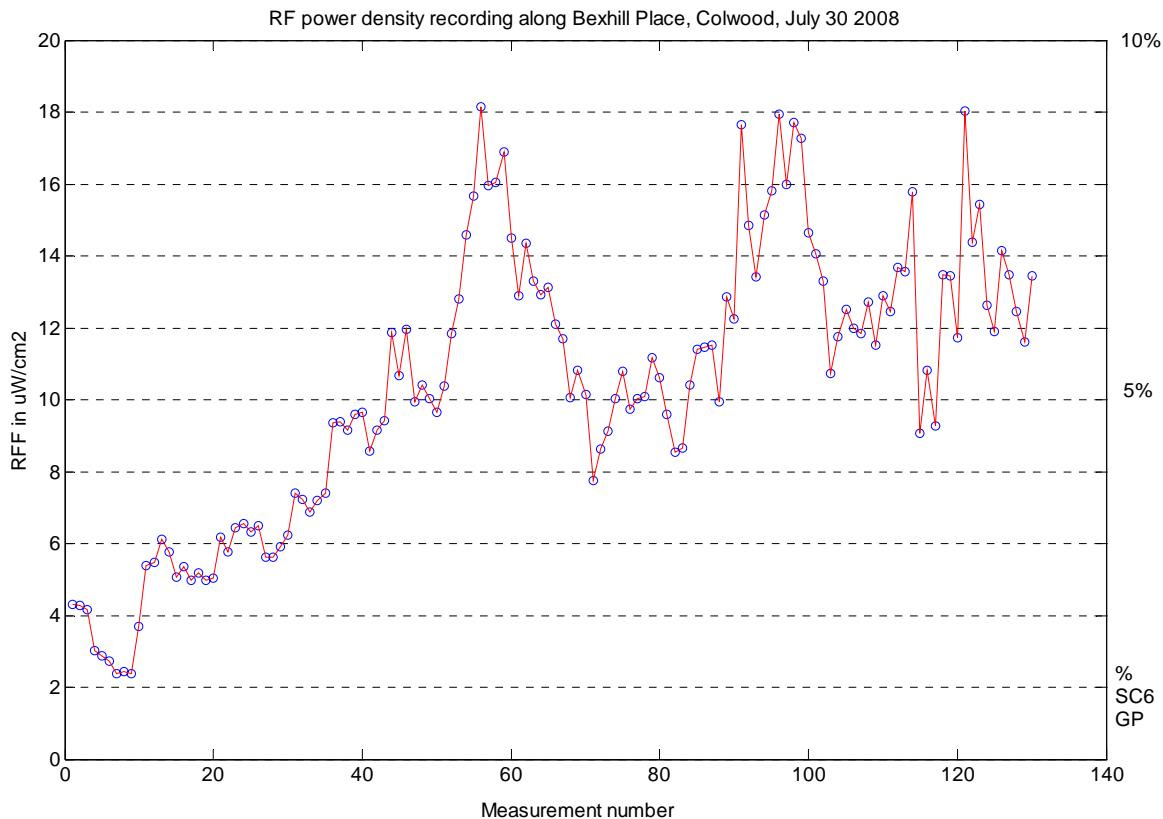
The results are plotted in **Figure 2**. The x-axis shows the count of data recorded; the left and right y-axis shows the power density in $\mu\text{W}/\text{cm}^2$ and in percentage of SC6 for the general public respectively.

The profile shows variations of the instantaneous RFF along Bexhill Place street. One observation is that the peaks were obtained when the measurement probe was in direct line of sight of the antennas (the clearance between two houses) and the valleys were obtained when the surveyor was in front of the houses. The average recorded was 5.2 % of the exposure limit of SC6 for the general public, and the maximum is measured as 9.1% of the exposure limit of SC6 for the general public.

Figure 2: Instantaneous RFF power density recorded along a section of Bexhill Place, Colwood, B.C., on July 30, 2008.

See **Figure 2** for the RF field strength measurements recorded along the selected section of Bexhill Place as expressed in unit $\mu\text{W}/\text{cm}^2$ (microwatts per square centimetre) and the respective measured percentage of exposure with respect to the SC6 general public level. At FM broadcast frequencies, the SC6 exposure limit in power density for the general public is $200 \mu\text{W}/\text{cm}^2$ or $2 \text{ W}/\text{m}^2$.

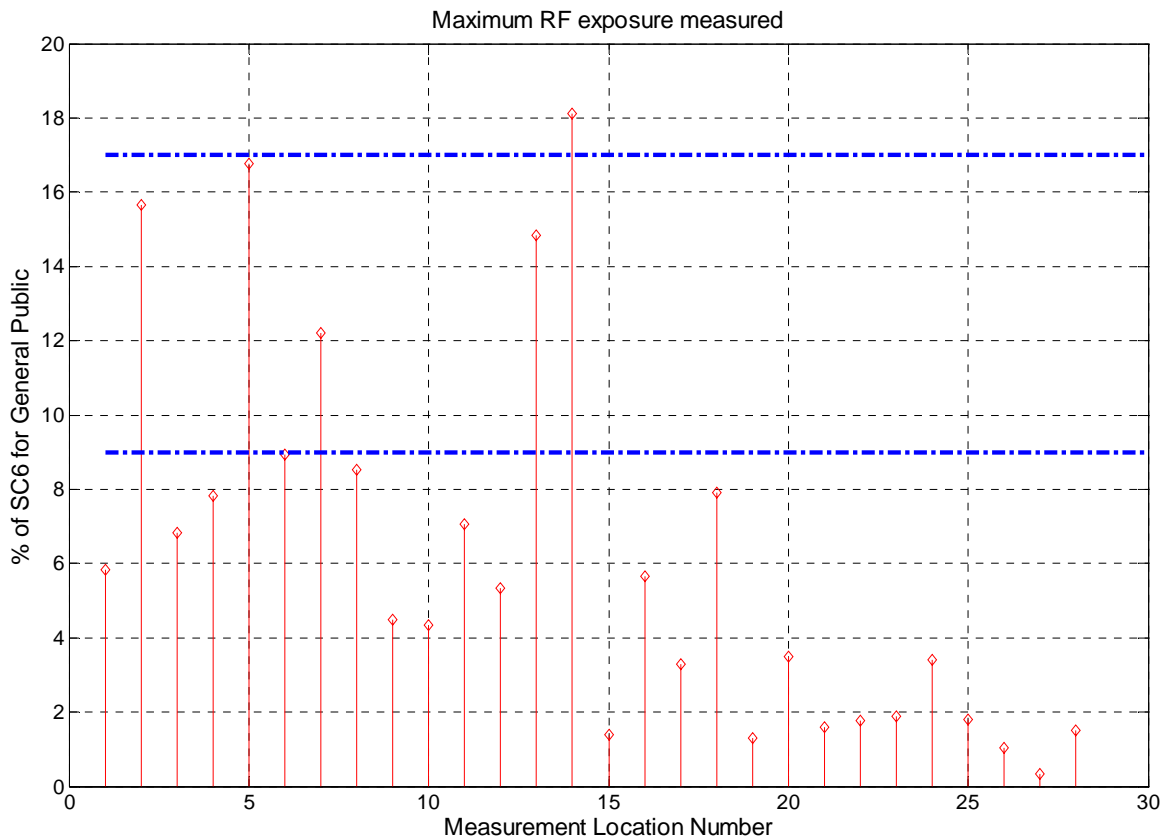
Figure 3 plots the highest measured RFF level (from two instruments) on July 30, 2008, at each of the 28 locations.

Figure 3: Maximum measured data for the 28 locations on Triangle Mountain in Colwood, B.C., during the survey on July 30, 2008.

- 23 measurements are less than 9% of the SC 6 exposure limit for the general public, which represents 82% of the locations;
- all measured locations, except for location #14, are less than 17% of the SC6 exposure limit for the general public; and
- the maximum RFF exposure measurement of 18.10% was found at location #14 due to the reflection effect at this particular location.

It was noted that locations #13 and #14 were on a balcony in direct line-of-sight with the antenna. Location #13 was a deck area with a table and chairs and location #14 was the walking corridor leading to location #13. This corridor is approximately 70-80 cm wide, and when measurement was made at location #14, the surveyor had a solid wall right at his back; this appeared to cause a reflection of the RFF. This location was suggested by the owner of the residence.

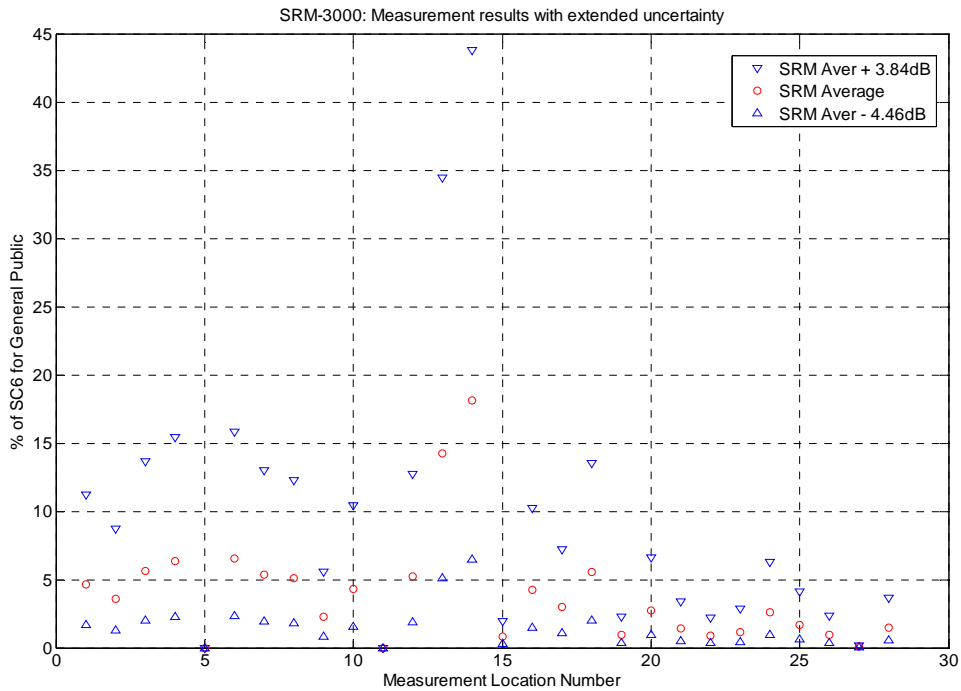
Figure 4.a.: Measurement results from July 30, 2008, on Triangle Mountain, using the SRM-3000, and the calculated upper and lower limits from extended uncertainty.

The extended measurement uncertainties for the SRM-3000 and Narda 8718B are +3.84 / -4.46 dB and +3.60/-3.60 dB respectively (see **Annex F**).

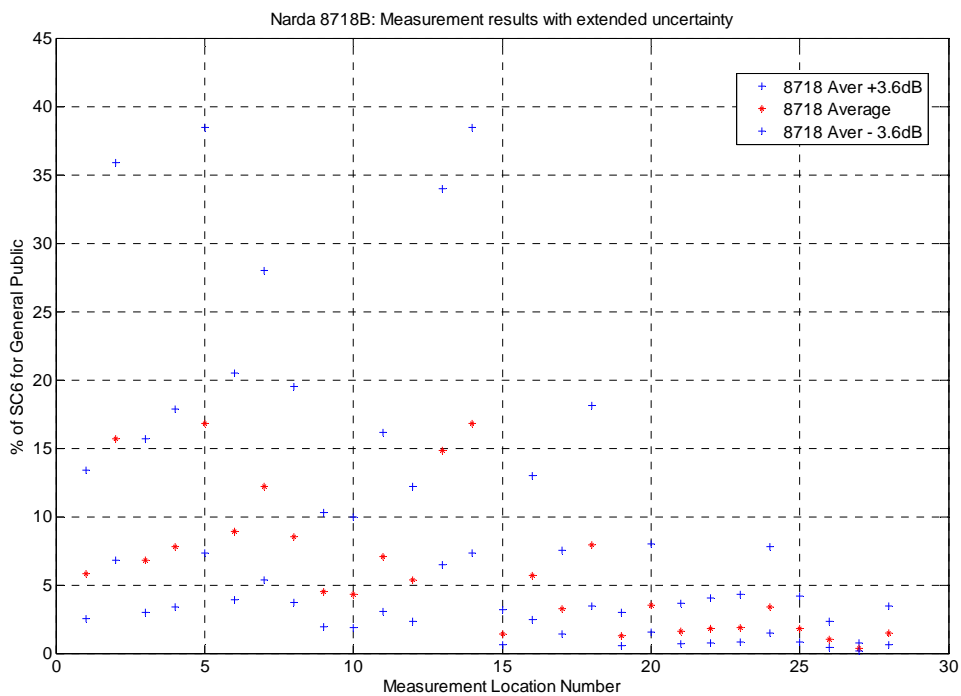
Figure 4.b.: Measurement results from July 30, 2008, on Triangle Mountain, using the Narda 8718B and the calculated upper and lower limits from extended uncertainty. (Note: Figure 5 shows the upper limits of all measuring data when extended uncertainty is considered.)

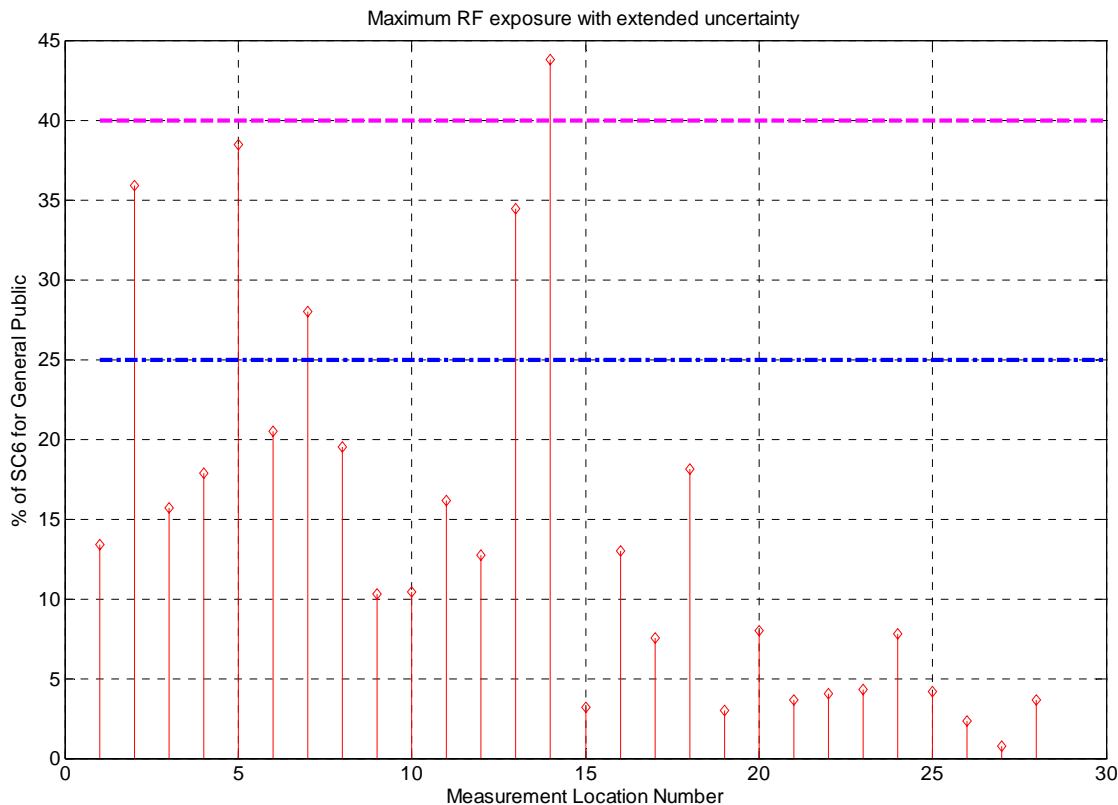
Figure 5: Calculated upper limit of the RF exposure (with extended uncertainty) at all measurement locations in the July 30, 2008 survey on Triangle Mountain, Colwood, B.C.

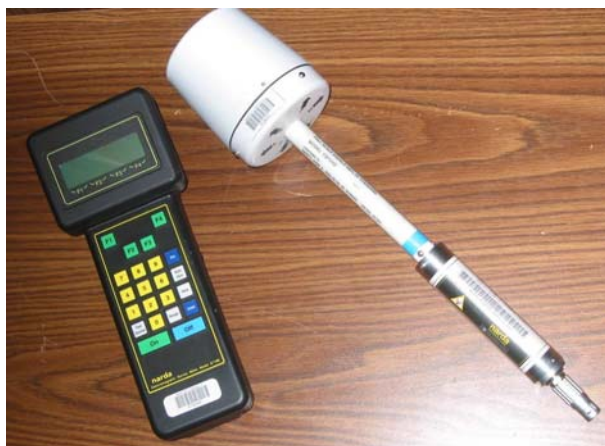
- probe C8722D is shaped according to Canadian Safety Code 6 (SC6) Standard;
- meter capable of time averaged measurement;
- full range scale 300% for RF workers;
- triaxial E field type probe; and
- meter displays instantaneous and “maximum hold” values.

This meter with the probe C8722D was set to measure and display the percentage of SC6 exposure limit for RF workers; the results displayed accounted for the total of all RFF contributions of all sources detected by the probe.

Figure B-1: Narda Electromagnetic Survey Meter 8718B with probe C8722D

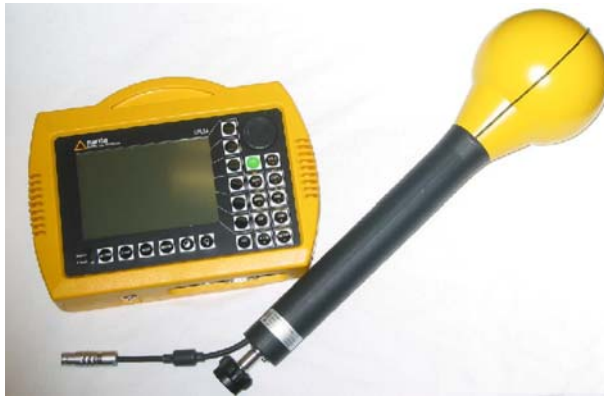
The second set of equipment, shown in **Figure B-2**, is the SRM-3000 with an isotropic antenna (or three-axis antenna) for electric field, which:

- integrates two modes of operation: Safety Evaluation and Spectrum Analyzer;
- provides the results in percentage of the SC6 exposure limit for the general public, for the RF workers or in many others units (V/m, W/m²...);
- gives the total RFF exposure of all sources detected by the probe; and
- computes automatically the contribution of individual services to overall field exposure.

This meter was set up to measure and display the percentage of exposure limit with respect to SC6 for the general public.

Figure B-2: Narda Selective Radiation Meter SRM-3000 with probe

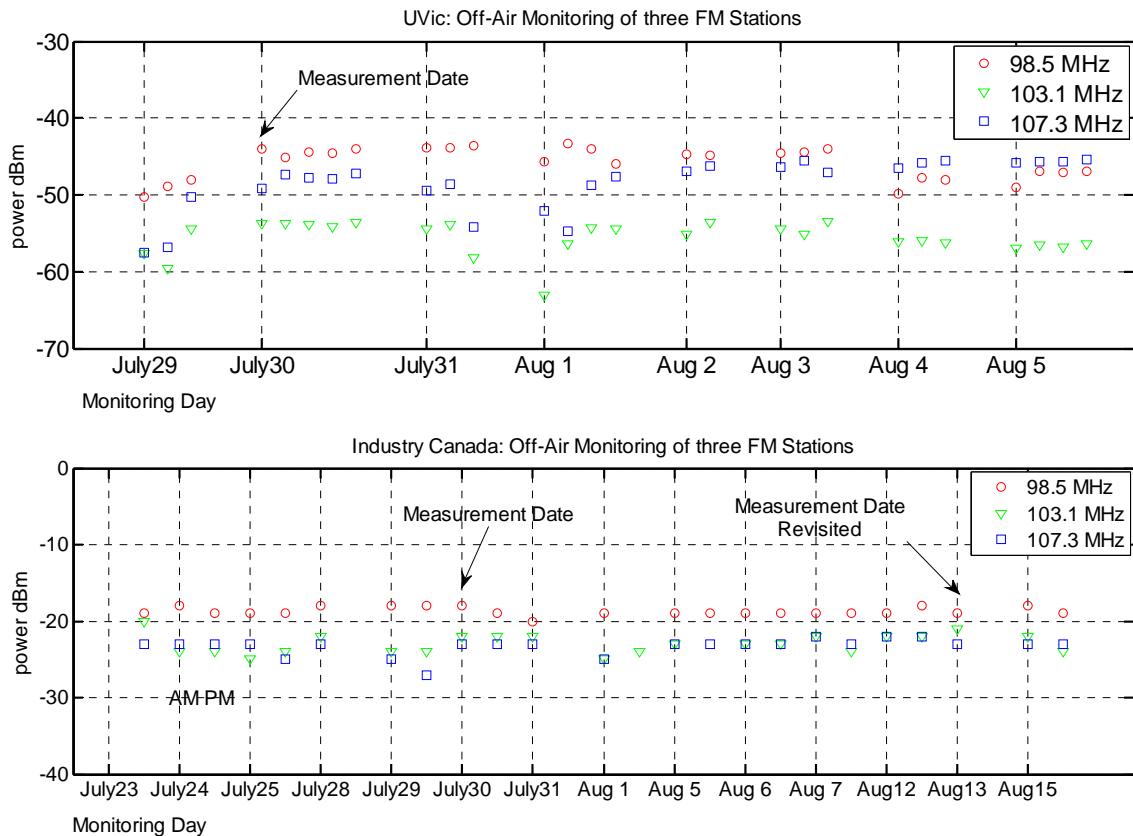
In addition, off-air monitoring was done by Industry Canada’s Vancouver Island District officials on the three FM channels from July 23 to August 15, 2008, inclusive.

The results of these two sets of measurements are presented here:

A third-party, off-air monitoring of the three FM stations was also conducted twice each day from July 29 to August 5, 2008, inclusive. **Annex C** shows the results of this monitoring of the three FM stations. No significant variation was noted in the measured signal levels from the three FM stations in this period. In addition, Industry Canada conducted similar off-air monitoring of the three FM stations from July 23 to August 15, 2008, inclusive (see **Annex C**). No significant variation was noted in the measured signal levels of the three FM stations in this period.

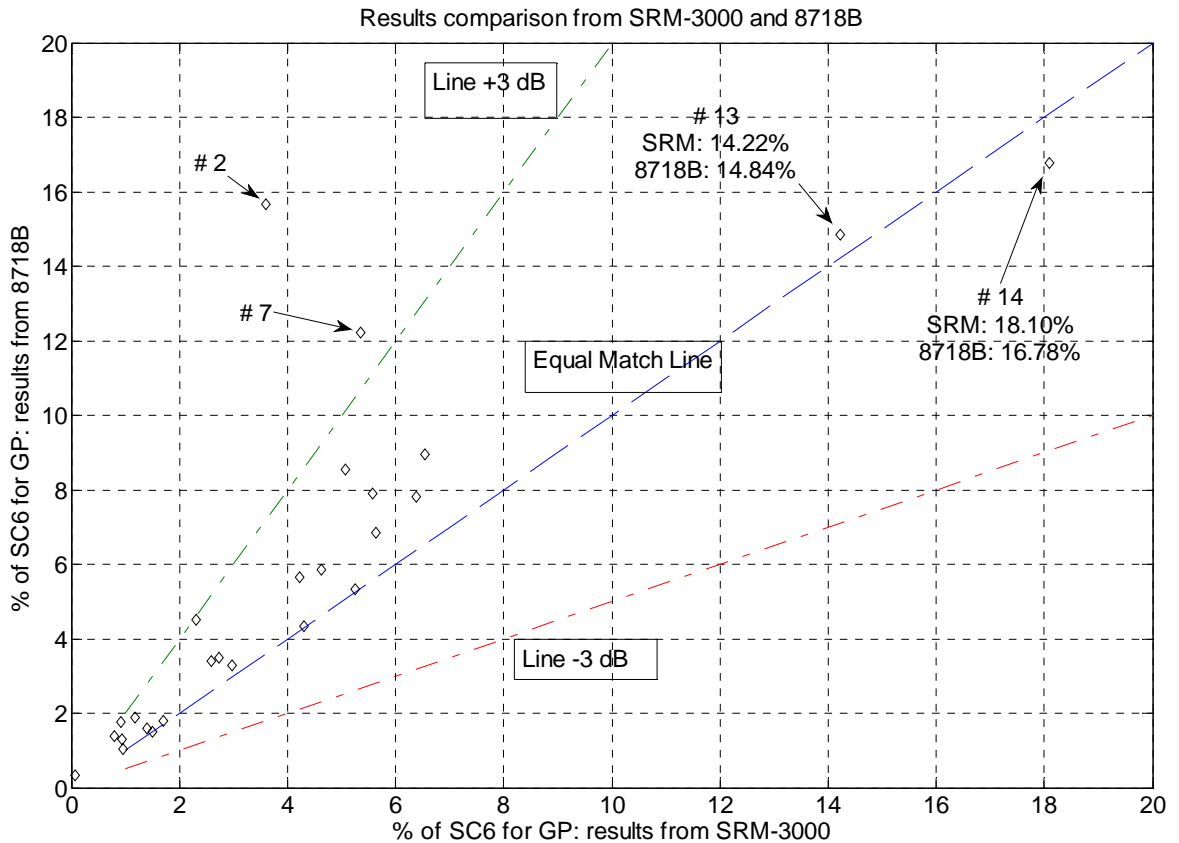
Although the results from the SRM-3000 and 8718B meters were closely matched in the survey on July 30, 2008, they were not identical. In a perfect match, all measurement results should be plotted on the middle line where measurements obtained from the two instruments are identical; for this measurement dataset, except for locations #2 and #7, all other measurement results are within the expected norm lines +/- 3 dB for sampling uncertainty. This is to be expected in field measurements, as there are many variations at work.

Figure E-1: Comparing results from the two instruments SRM-3000 and 8718B.

- measurements that resulted from two instruments (columns 2 and 4) agree within +/- 3dB, except for locations #2 and #7 (see **Annex E**);
- in general, readings from the SRM-3000 are lower than those from the 8718B;
- at some locations, the measured RFF from the 2008 survey are one-half of the measured RFF from the 2001 survey; and
- at location #14, both instruments recorded a maximum RFF.

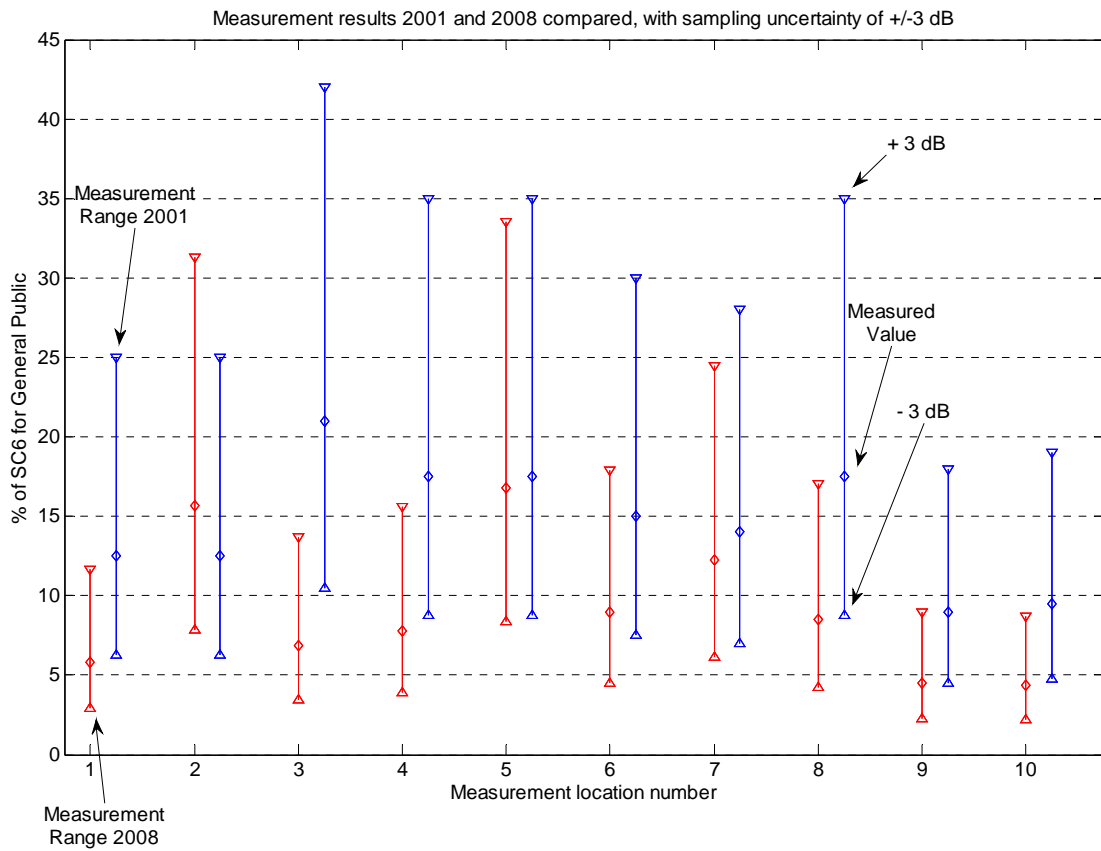
With sampling uncertainty of ± 3 dB taken into account, **Figure G-1** shows the expected ranges for each measurement of the two datasets, one in 2008 and one in 2001. For each measurement location, the two vertical bars indicate the measurement ranges corresponding to surveys 2008 and 2001. Each vertical bar is shown with the measured value, and the range of dots from an upper limit of $+3$ dB to a lower limit of -3 dB (from the measured value), to account for the sampling uncertainty ± 3 dB.

For each measurement location, the two range values from surveys 2008 and 2001 always intersect with each other. This indicates the validity of these two measurements under the defined uncertainty.

Figure G-1: Comparison of the measurement results at 10 locations from the surveys in July 2008 and May 2001 on Triangle Mountain, Colwood, BC.

At 10 public accessible locations where measurements were made in 2001, the survey team repeated measurements in July 2008, and then again in August 2008. The two measurements taken seven years apart could not be exactly the same due to factors including: slight variation in location in spite of the best effort by the surveyor, position of surveyor, how the probe is handled by the surveyor, the direction the probe is pointed to, weather conditions, changes in local environment such as new residential development, tree growth etc.
